# Memorandum

SUBJECT: Groundwater Conditions under Twenty Seven Acres of Land situated in the Vicinity of the S10.7 Lateral Headworks Structure at Station 10+717 on the Shamalan Canal - Owner: Mohamad Din, Parcel No. 202

SHAMALAN S10.7 LATERAL

DEPTH TO WATER ON TRIANGULAR PARCEL OF LAND NEAR STA. 01000

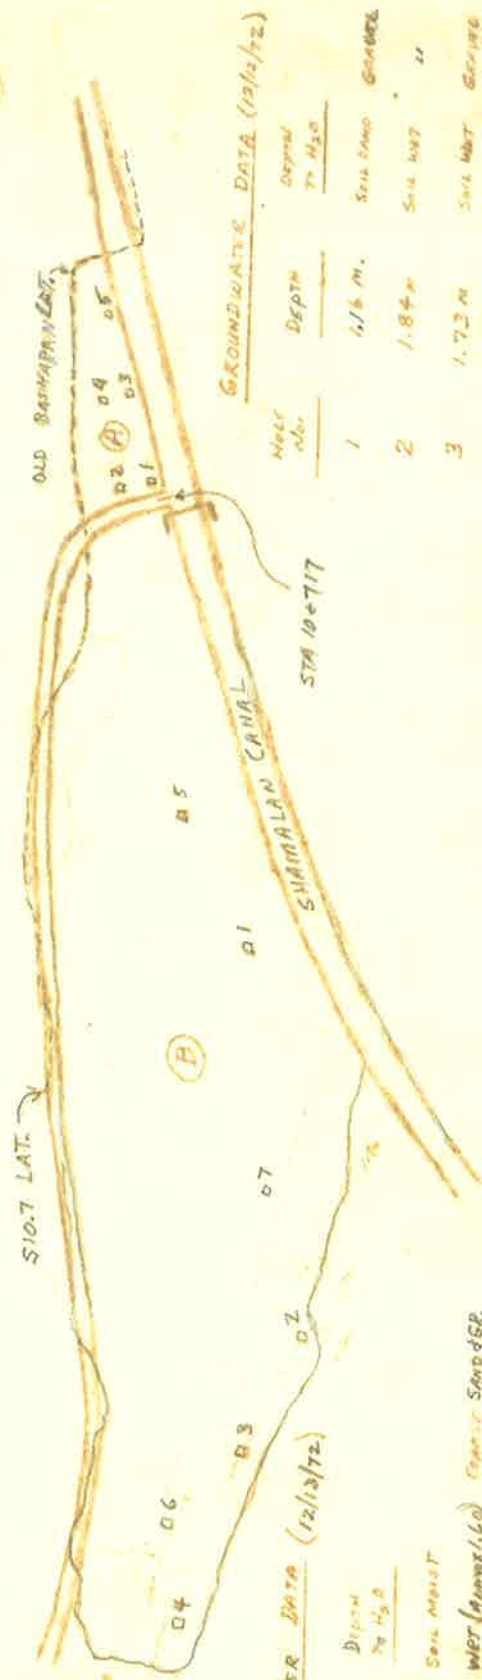
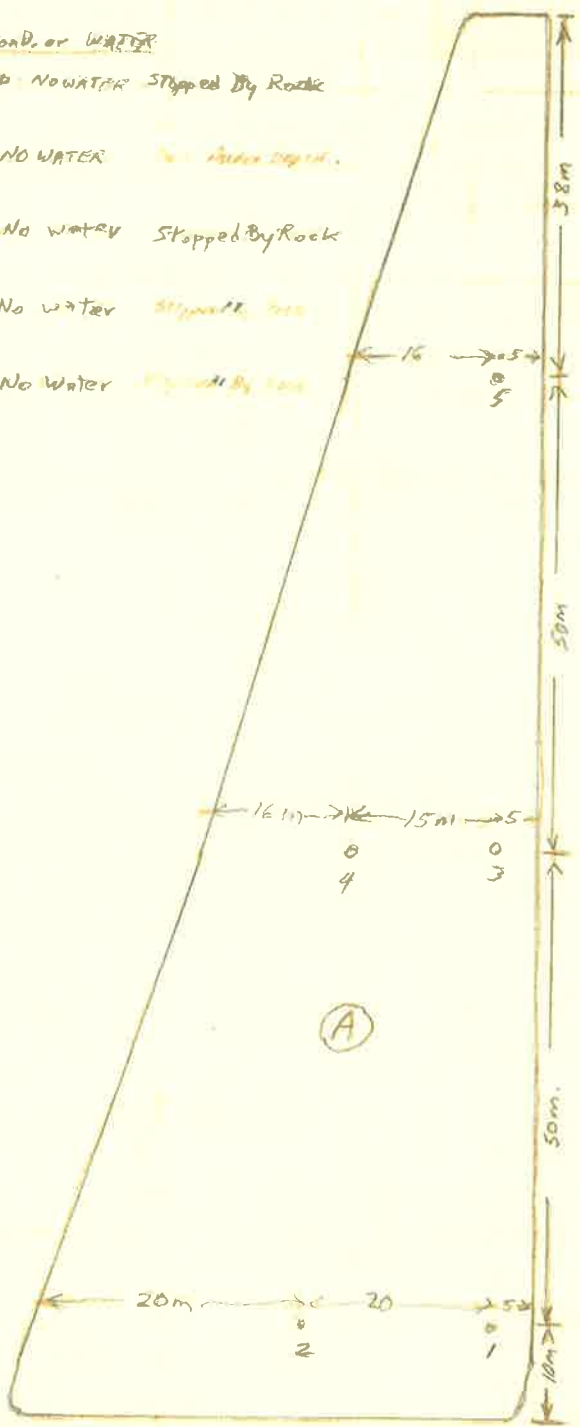
Gravelly subsurface conditions in this area, which were encountered and observed during the construction of the new headworks structure, indicated that drainage problems shouldn't develop in this area provided proper irrigation practices were used. In order to substantiate this assumption a total of 12 auger holes were sunk at various points within the boundaries of the parcel of land in question, 5 of which were in the small triangular piece of land previously mentioned. The two attached sketch maps give the location of the holes together with the depth of the hole and the depth below the ground surface, to the groundwater surface, if any was encountered. The depth of these holes was limited to 1.84 - 1.85 meters, the effective length of the auger used. Note that although the water surface in the Shamalan Canal was approximately 0.50 meters above the ground surface and holes 1, 3 and 5, in the triangular piece were only about 10 - 12 meters from the edge of the water in the canal, there was no groundwater encountered within 1.60 - 1.73 meters

HOSE No.	DEPTH	DEPTH TO H <sub>2</sub> O	SOIL TYPE
1	1.85 m		SAND
2	1.50 m		WET (Approx. 1.0) Coarse SAND
3	1.80 m	1.60	Coarse SAND + FINE GR
4	1.80 m	1.55	" " " "
5	1.85 m		SAND WET
6	1.85 m	1.72	Coarse SAND + FINE GR
7	1.85 m	1.84	" " " "

HOSE No.	DEPTH	DEPTH TO H <sub>2</sub> O	SOIL TYPE
1	1.15 m		SAND
2	1.84 m		SAND WET
3	1.73 m		SAND WET
4	1.70 m		SOIL WET
5	1.60 m		SAND WET

HOLE NO.	DEPTH	SPID. COND. OR WATER	REMARKS
HOLE NO. 1	1.16m	DAMP NO WATER	Stopped By Rock
HOLE NO. 2	1.84m	WET NO WATER	Area Sealed.
HOLE NO. 3	1.73m	WET NO WATER	Stopped By Rock
HOLE NO. 4	1.70m	Wet No water	Stopped By Rock
HOLE NO. 5	1.60m	Wet No Water	Stopped By Rock
