15 FEB 2001

**SUBJECT: *PROJECT PROPOSAL FOR THE RECONSTRUCTION OF  
THE CHAN-I-ANJIR SUSPENSION FOOT BRIDGE IN CENTRAL  
HELMAND PROVINCE, AFGHANISTAN***

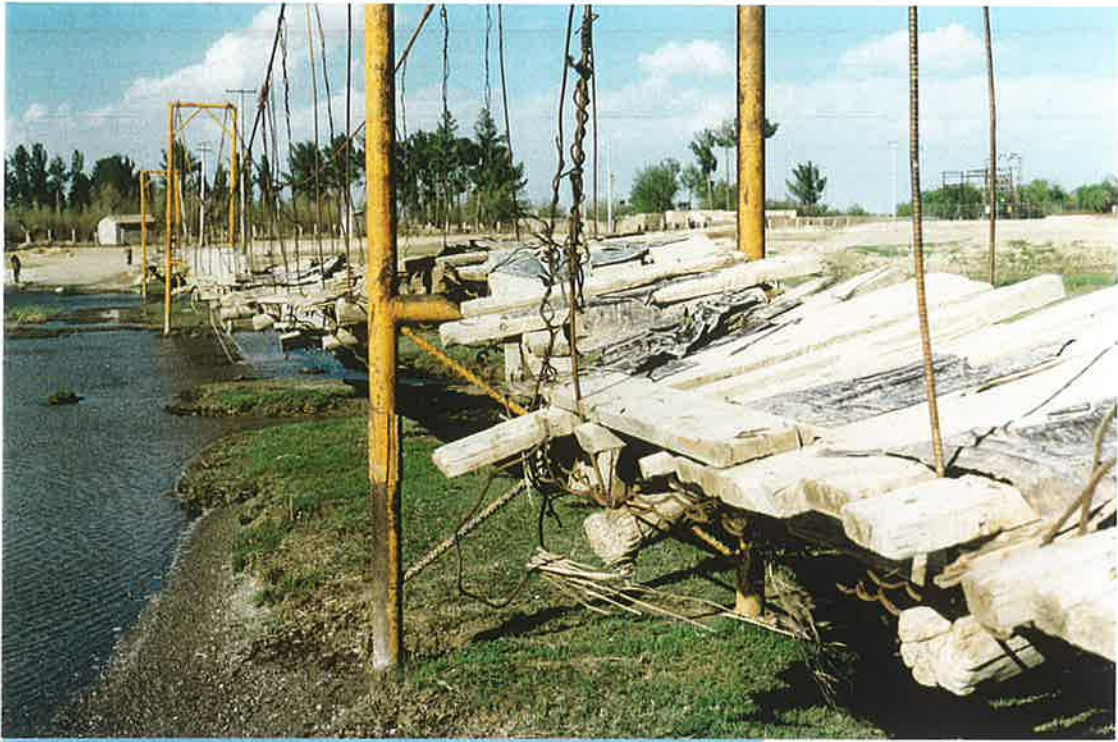
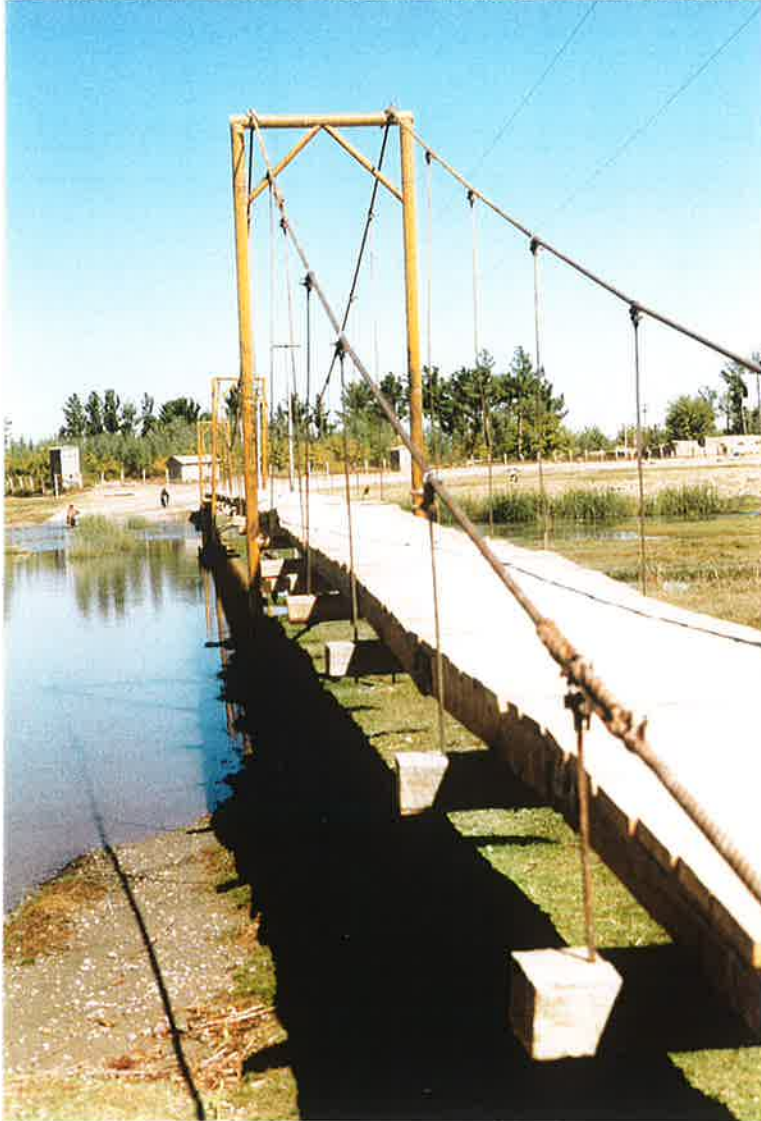
*March and October  
1997  
Before and After  
Chan-I-Anjir  
Footbridge repaired  
with U.N. funding from the  
east. Note vehicle ford left  
center. HAVA heavy  
equipment yard is among the  
trees in center.*

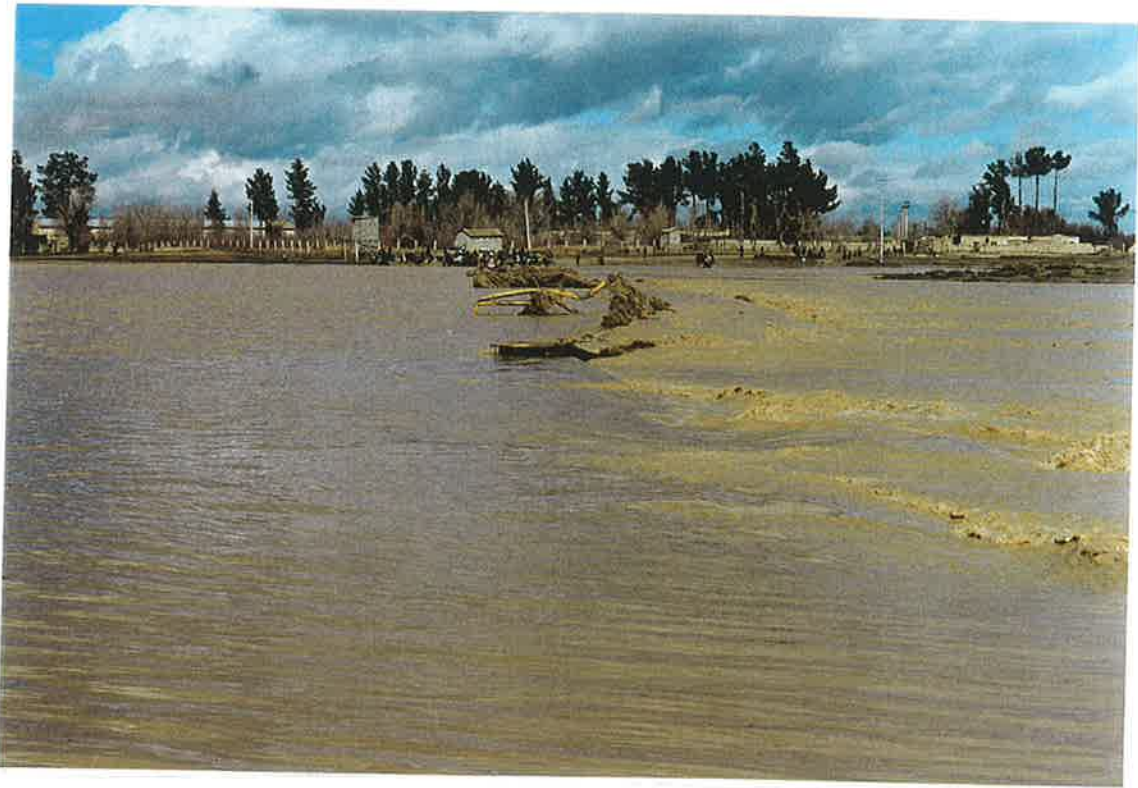
THE CHAN-I-ANJIR SUSPENSION FOOT BRIDGE WAS BUILT BY MORRISON-KNUTSEN CONSTRUCTION CO. OF BOISE, IDAHO IN THE LATE 1950'S OR EARLY 1960'S AS A VERY SMALL PART OF THEIR REGIONAL DEVELOPMENT ACTIVITIES. THE BRIDGE, WITH A SPAN OF OVER 100 METERS AND THREE PIERS, HAS RECEIVED LITTLE MAINTENANCE OVER THE PAST 20 YEARS. MAJOR REPAIR WORK WAS DONE DURING 1997 WITH UNITED NATIONS FUNDING (SEE PHOTOS #1 AND #2). BUT WITH HEAVY USE THIS SUSPENSION BRIDGE BEGAN TO SAG IN 1998 IN THE TWO MIDDLE SECTIONS. DURING THE RECORD FLOOD OF 7 FEB 1999, THE FLOOD WATERS CAUGHT THIS LOW POINT ON THE BRIDGE AND THE ENTIRE BRIDGE WAS PULLED DOWN.

*7 February 1999: Flood at Chan-I-Anjir footbridge. Note traffic jam at start of vehicle ford, top center. HAVA heavy equipment yard buildings are at top left, inside fenced area.*

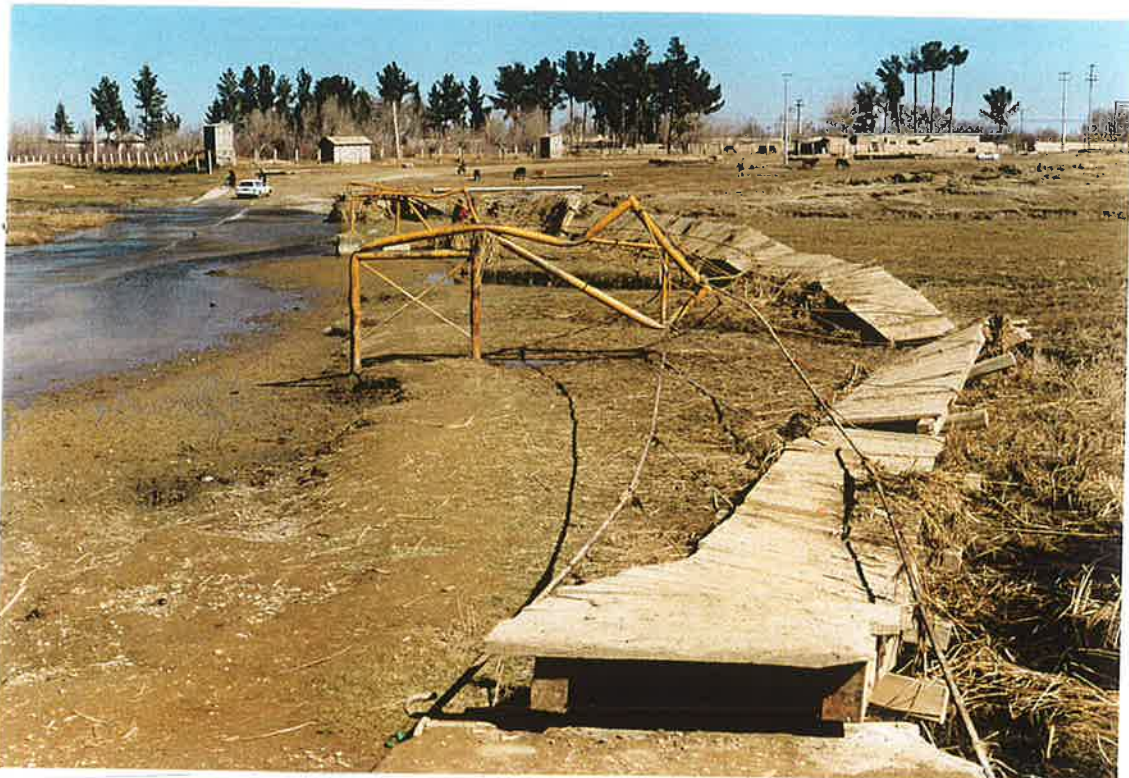
*15 February 1999: Chan-I-Anjir footbridge in need of repair, from the east. Note vehicle ford on the left.*

- CUT THE PIPE PIER STRUCTURES JUST ABOVE THE FIRST CROSS SECTIONS (SEE PHOTOS #4, #5 AND #6). REPLACE, REINFORCE AND WELD THE NEW PIPE STRUCTURES INTO PLACE.

- LUBRICATE AND RE-SUSPEND THE OLD CABLES INSURING THAT THROUGH HEAVY USE, THE CABLES WILL NOT SAG. THE CABLES, ALTHOUGH OLD, APPEAR TO BE IN RELATIVELY GOOD CONDITION. APPARENTLY SOME OF THE NEW CONCRETE SLABS LAID IN THE 1998 REPAIR WERE LAID ON TOP OF THE SUSPENSION CABLES THAT REQUIRED FLEXIBILITY (SEE PHOTO # 6). WITH HEAVY USE THE CONCRETE SLABS MOVED ALLOWING THE CABLES TO SAG, AND PUTTING THE BRIDGE IN HARMS WAY.

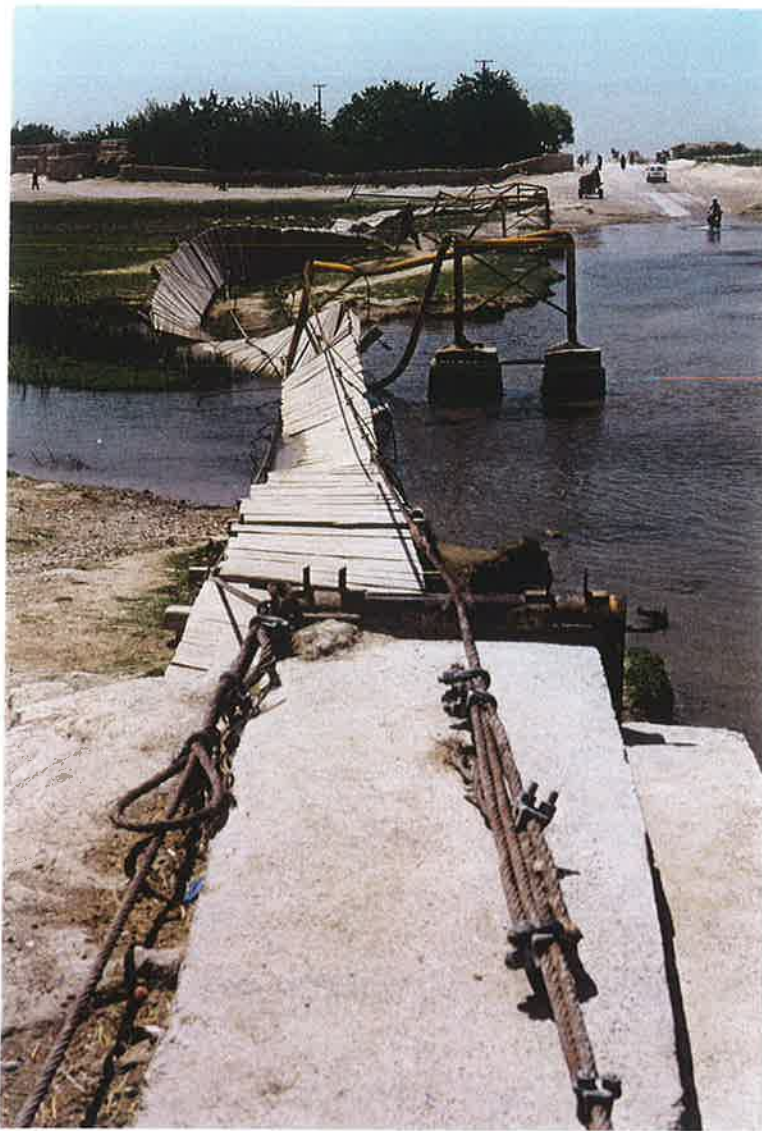
***24 April 2000: Chan-I-Anjir footbridge from the west Chan-I-Anjir side. Note the vehicle ford top right.***

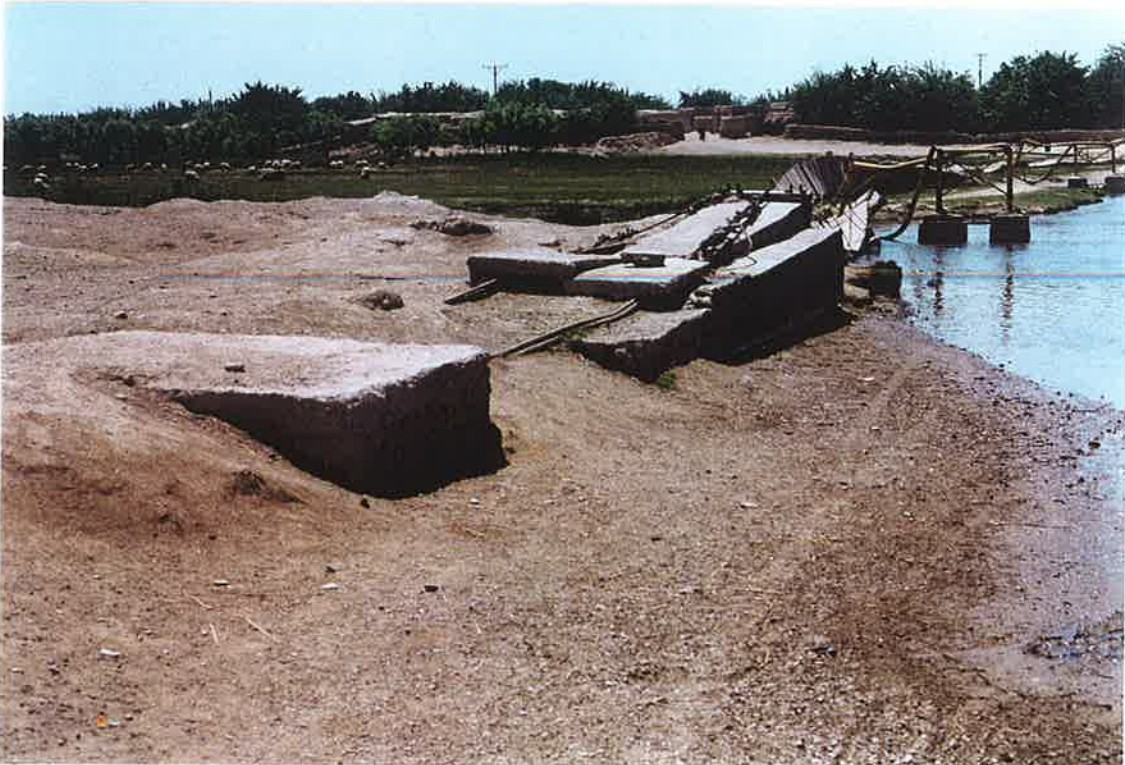
***24 April 2000: Concrete approach to Chan-I-Anjir footbridge in need of repair, from the west. Note sizable village settlement across the wash.***

- REBUILD THE CENTER SECTION OF THE CONCRETE APPROACH TO THE BRIDGE ON THE WESTERN SIDE (SEE PHOTO # 6).
